FACILITY INSPECTION REPORT

| Facility No: | M6-0493 | Fiscal Year: | 2010 |
| Facility Name: | Industrial Area Support Building | Inspection Date: | 01/10 |
| Location: | Kennedy Space Center (KSC) Industrial Area | Facility Owner: | NASA |

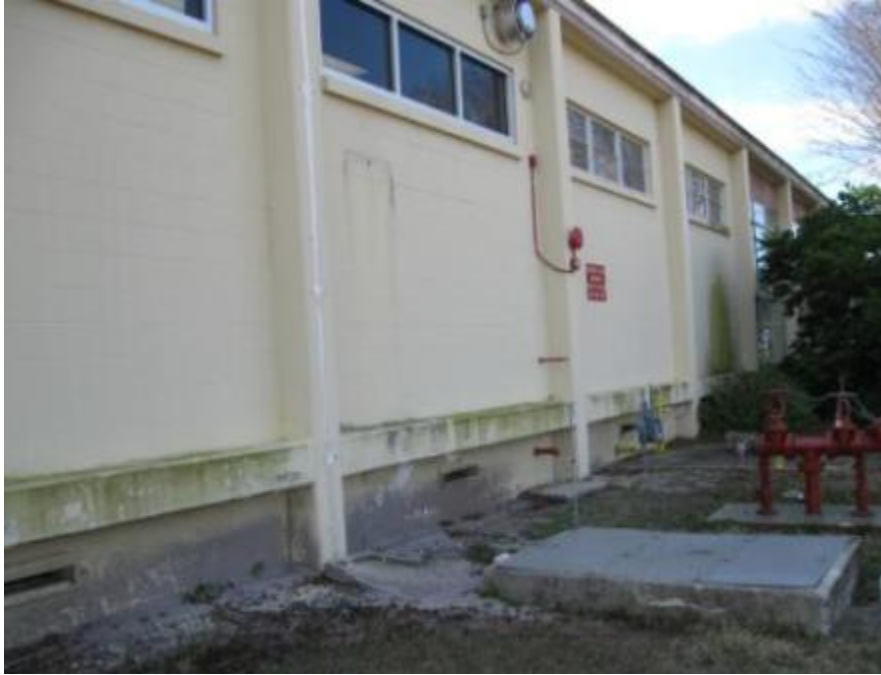
fair condition. The painted exterior shows signs of wear. Mold/mildew is present along the north exterior wall (see Figure 2 and 3). Multiple hairline cracks have appeared on the exterior north and south ledges. Hairline cracks are also visible along the east and west vertical exterior pillars. Along the exterior north ledge rebar is visible in one place. There is a smell of mold at the northwest entrance. A new roof is currently being constructed.

Figure 2. Mildew/mold growth along Northeast side

exterior, paint the building exterior and on the west side, replace the damaged carpet and ceiling tiles where leaks have occurred.

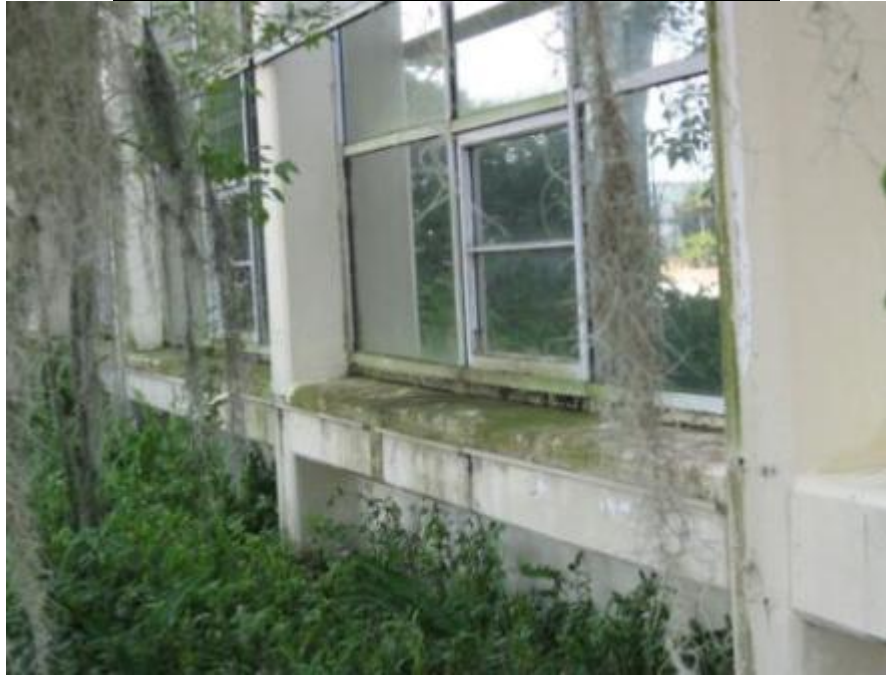
Figure 3. Mildew Along Northwest Side - M6-493

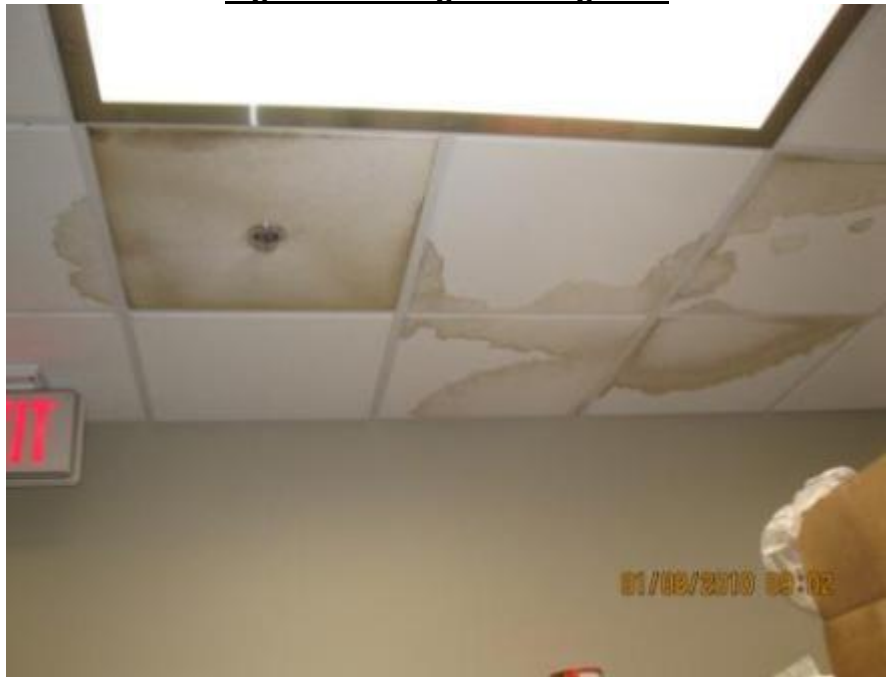
The west half has had constant leaks appearing (See Figure 4). Installation of the new roof in Spring 2010 should eliminate these leaks. Pressure washing the exterior north wall to remove mold is needed every few years.

Figure 4. Damaged Ceiling Tiles

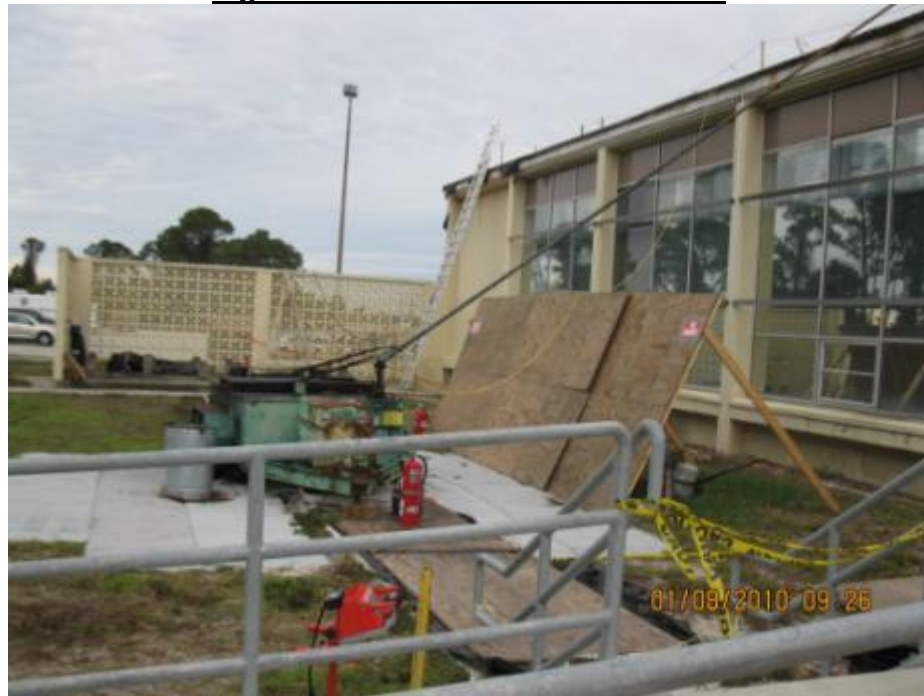
Figure 5. Roof Construction - M6-493

The facility roof is a built-up roof and is currently being replaced with a new roof. Sections have been repaired numerous times over the life of the facility. The roof is currently being replaced (Figure 5) with a completion date of Spring 2010.

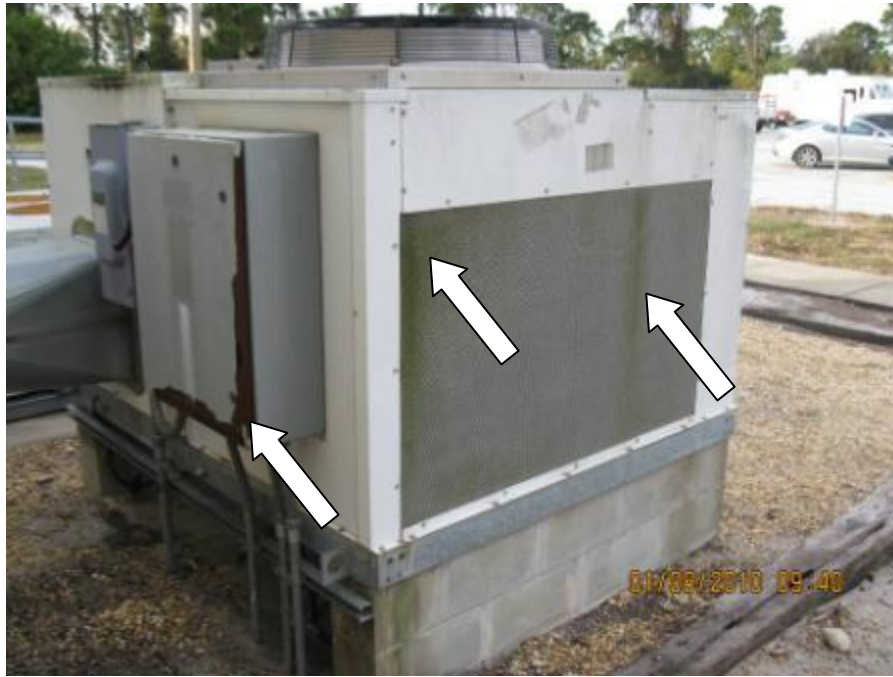
- The condenser coils on the outdoor air package unit (Asset CIAIAUA001) have mildew growing on them and advanced corrosion exists on this unit's electrical/control box (see Figure 6). The condenser coils should be cleaned to remove mildew from the coils and the electrical/control box should be corrosion controlled and repainted to prevent premature deterioration.

Figure 6. Corrosion and Biological Growth on Package Unit

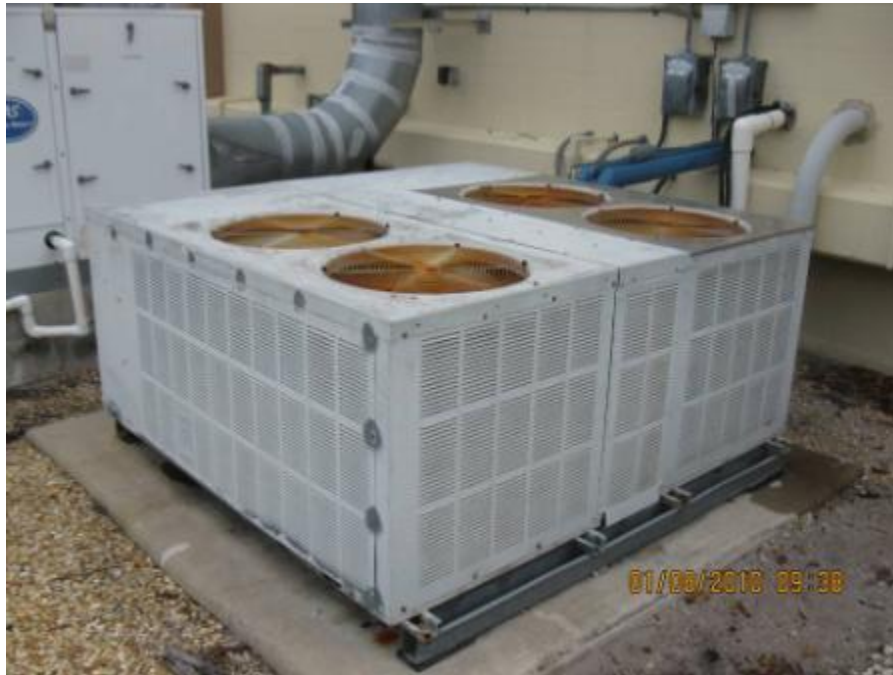
- The Trane heat pump condenser (Asset CIA02001) and AHU (Asset CIA02002) servicing the west side of the building are 25 years old and have exceeded their recommended service lives (see Figure 7 and 8). Replacement of these units is recommended to increase energy efficiency, reduce maintenance burden and to prevent frequent HVAC outages. This condenser and AHU will be replaced under active WON E1045064. The status of this work order is approved (APPR).

Figure 7. Aged Heat Pump Condenser Unit

WON E1045064 – This WON is in place to replace the air conditioning condenser and air handler on the west side of the facility due to the age of the units. An existing 12.5 ton air conditioning unit from the HVAC storage yard will be used to replace the existing unit. The status of this work order is approved (APPR).

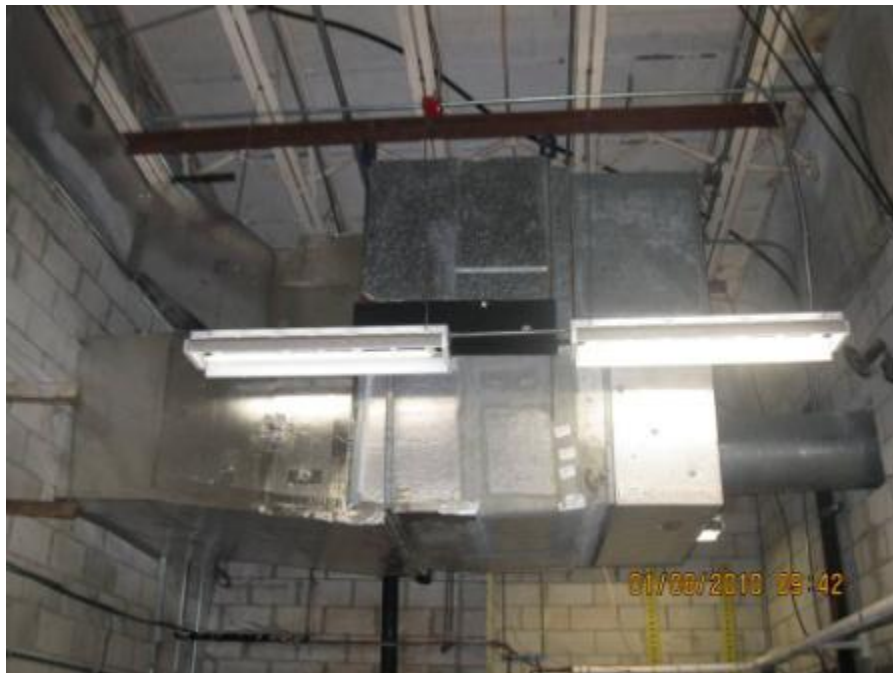
Figure 8. Aged Air Handling Unit

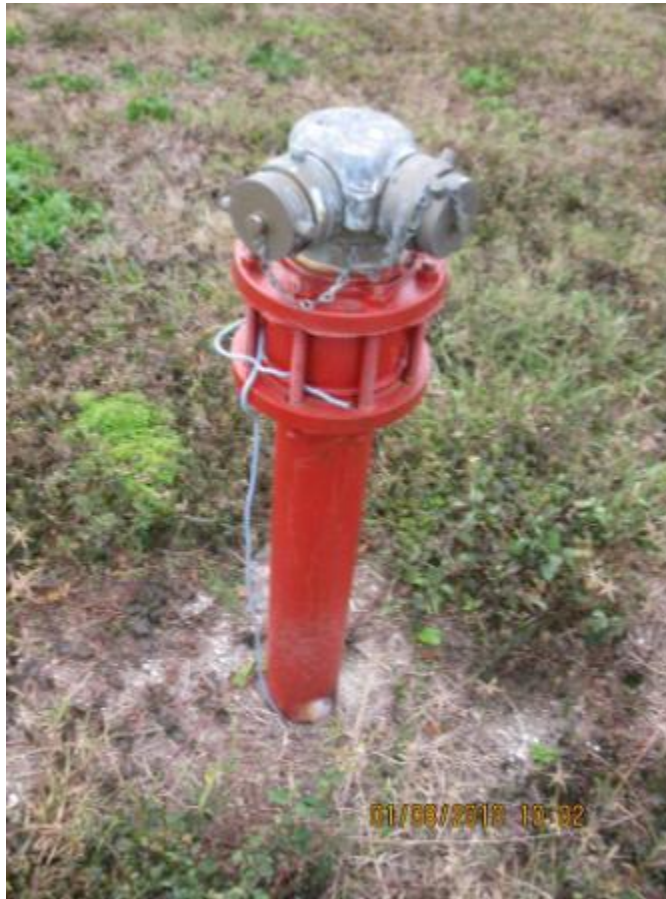
- No identification sign exists on the FDC servicing the sprinkler system in the Lackmann area (see Figure 9). A hang tag or other appropriate identification markings should be installed to comply with NFPA Code. No other deficiencies were identified with the suppression system's components.

Figure 9. No Identification Sign or Markings on FDC

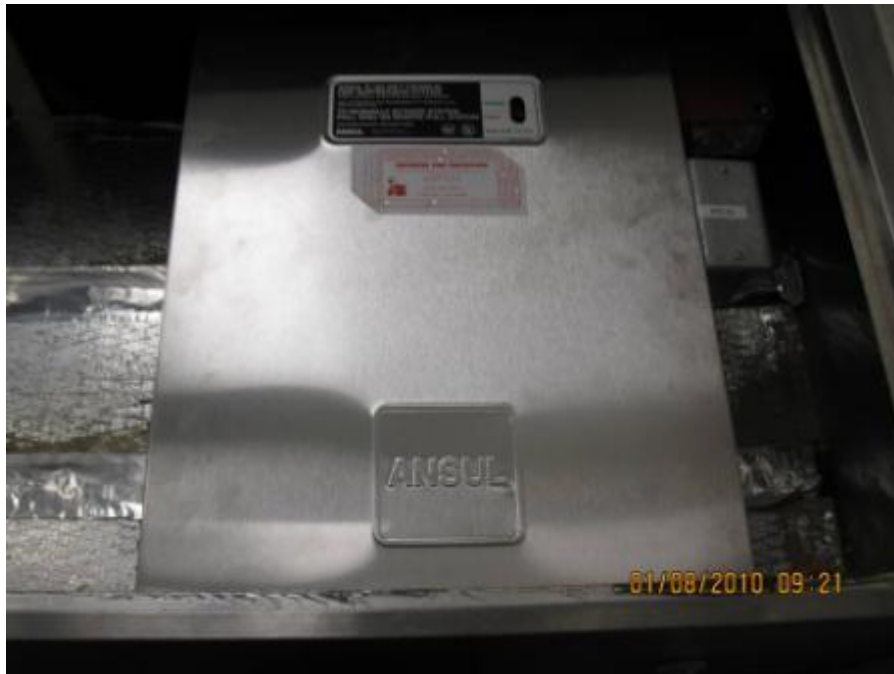
Figure 11. Ansul Wet Chemical Fire Suppression System

An Ansul R-102, wet chemical fire suppression system exists in the kitchen cooking area located on the east side of Facility M6-0493 (see Figure 11). This equipment should be added to Maximo with appropriate preventive maintenance. The OMEU assigns maintenance responsibility to ISC for the SC subsystem.

| Table 1. Maximo Recommendations | |
|---|---|
| PSY/SC | An Ansul R-102, wet chemical fire suppression system exists in the kitchen cooking area located on the east side of Facility M6-0493 (see Figure 11). This equipment should be added to Maximo with appropriate preventive maintenance. The OMEU assigns maintenance responsibility to ISC for the SC subsystem. |
